Nevada
Environmental
Restoration
Project

Closure Report for Corrective Action Unit 145: Wells and Storage Holes, Nevada Test Site, Nevada

February 2008

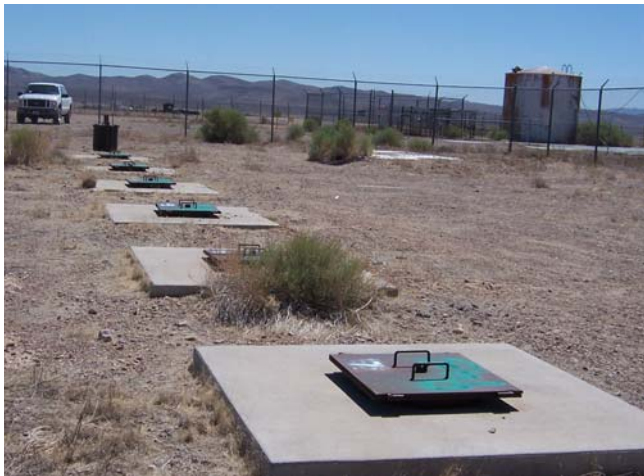
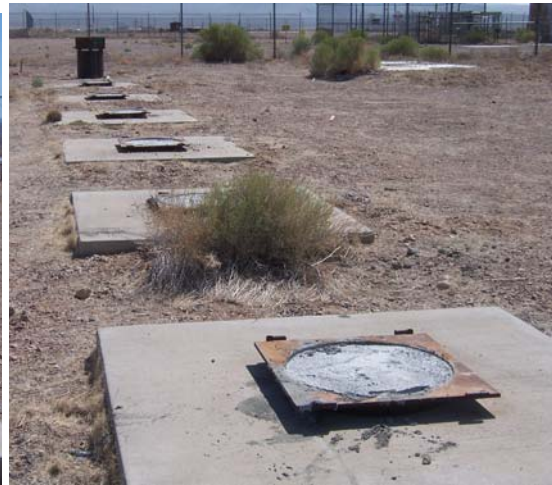
FIGURE 2. CAS 03-20-01, CORE STORAGE HOLES

Before (08/09/2007)

After (09/06/2007)

CAS 03-20-01 is located at the former Core Complex in Area 3 of the NTS. It consists of seven cased core storage holes. No further action was required for closure of this CAS. As a BMP, all seven holes were grouted to grade. Metal covers were surveyed to verify that radiological contamination was less than the free-release limit established in the *NV/YMP Radiological Control Manual* (NNSA/NSO, 2004), after which the covers were placed into metal stockpiles for use elsewhere on the NTS. Photographs of the site before and after closure activities are provided in Figure 2.

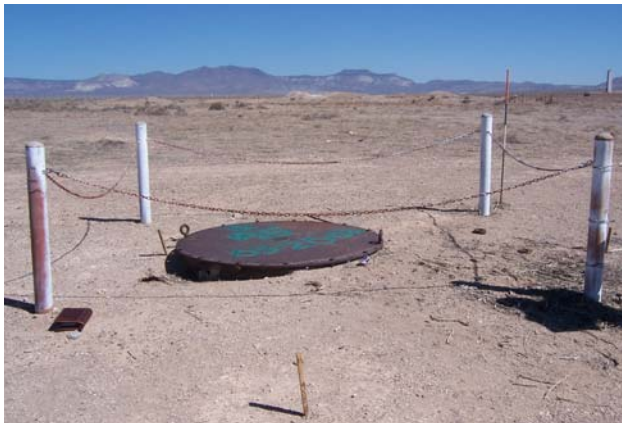
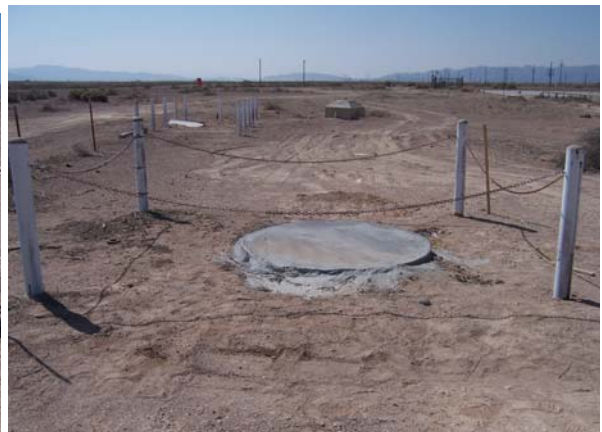
FIGURE 3. CAS 03-20-02, SUMP

Before (08/09/2007)

After (09/06/2007)

CAS 03-20-02 is located near the junction of Mercury Highway and the BJY Road. No further action was required for closure of this CAS. As a BMP, the sump was grouted to grade. The metal cover that had covered the sump was surveyed to verify that radiological contamination was less than the free-release limit established in the *NV/YMP Radiological Control Manual* (NNSA/NSO, 2004), after which it was placed into metal stockpiles for use elsewhere on the NTS. Photographs of the site before and after closure activities are provided in Figure 3.

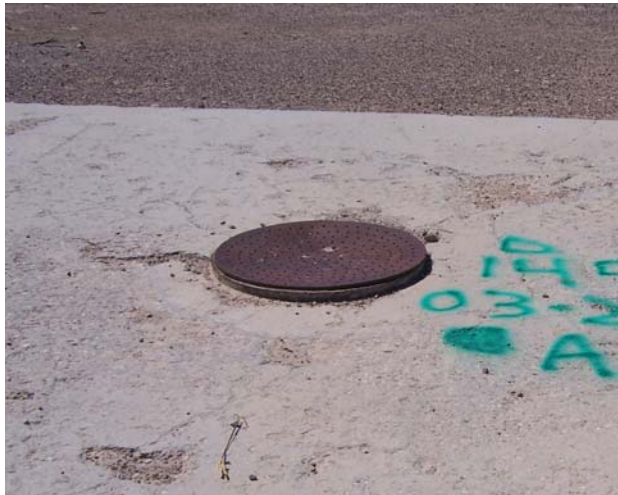
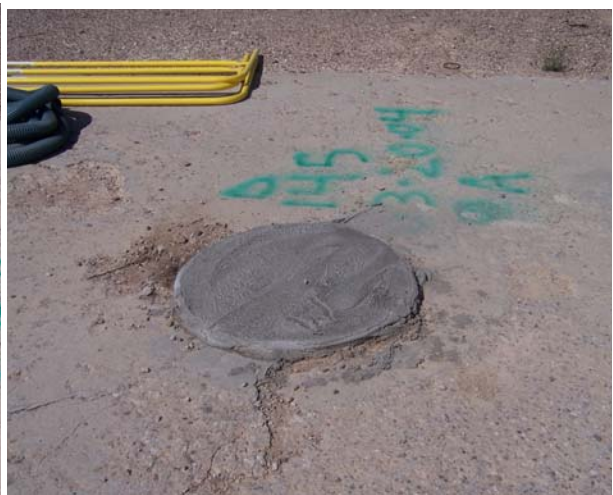
FIGURE 4. CAS 03-20-04, SITE A INJECTION WELL

Before (08/09/2007)

After (09/06/2007)

- Approximately 600 gallons of liquid were pumped from the Site C injection well and disposed of at the Area 12 Sewage Lagoon.
- Approximately 100 gallons of liquid were pumped from the Site E steel-cased hole and disposed of at the Area 12 Sewage Lagoon.
- Three injection wells (Sites A, B, and C), two sumps (Site D and steam plant sump), and one steel-cased hole (Site E) were filled to grade with grout. No liquid was removed from the steam plant sump because it was dry during closure activities.
- Metal covers from the wells and sumps were surveyed to verify that radiological contamination was less than the free-release limit established in the *NV/YMP Radiological Control Manual* (NNSA/NSO, 2004), after which the covers were placed back into metal stockpiles for use elsewhere on the NTS.

Photographs of each location before and after closure activities are provided in Figures 4 through 9.

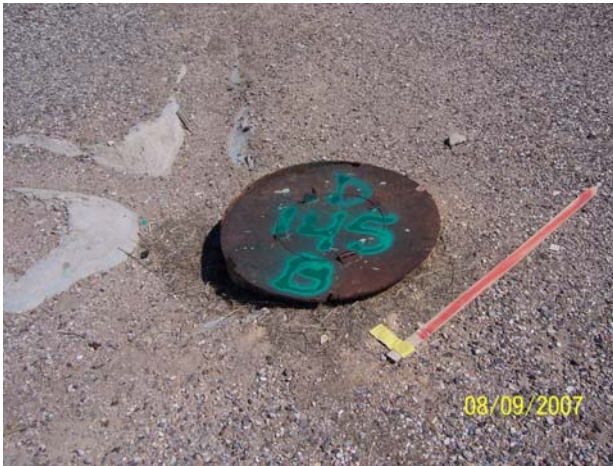
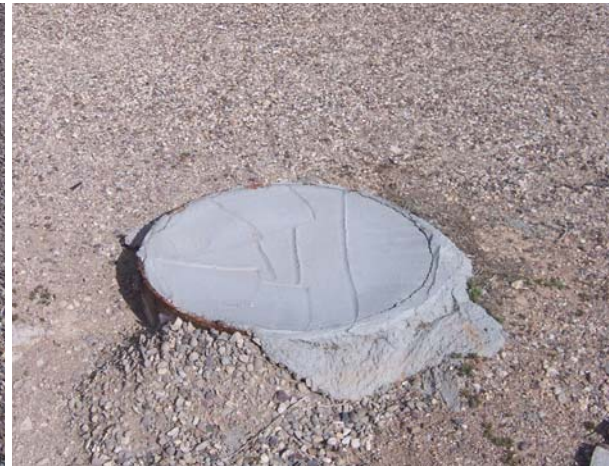
FIGURE 5. CAS 03-20-04, SITE B INJECTION WELL

Before (08/09/2007)

After (10/15/2007)

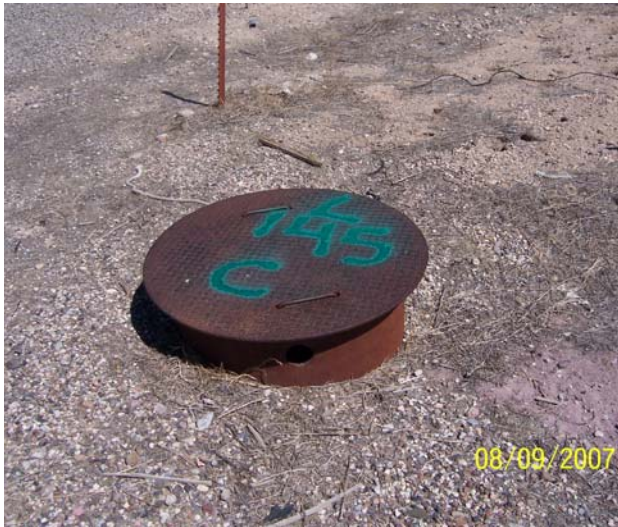
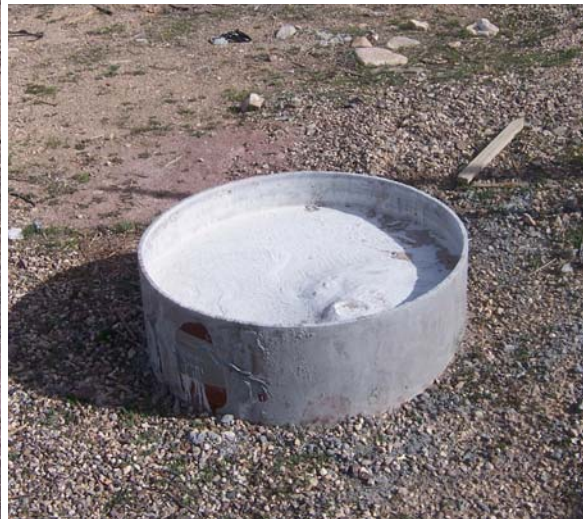
FIGURE 6. CAS 03-20-04, SITE C INJECTION WELL

Before (08/09/2007)

After (10/15/2007)

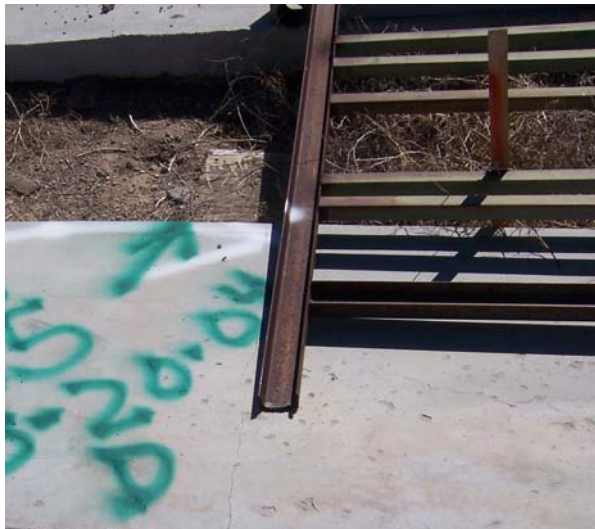
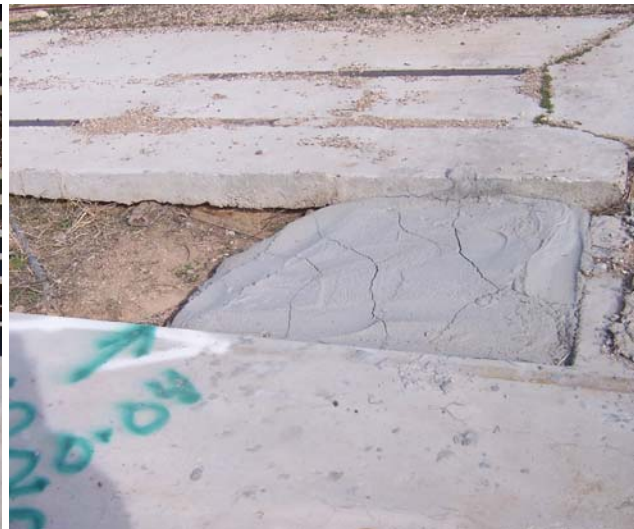
FIGURE 7. CAS 03-20-04, SITE D SUMP

Before (08/09/2007)

After (10/15/2007)

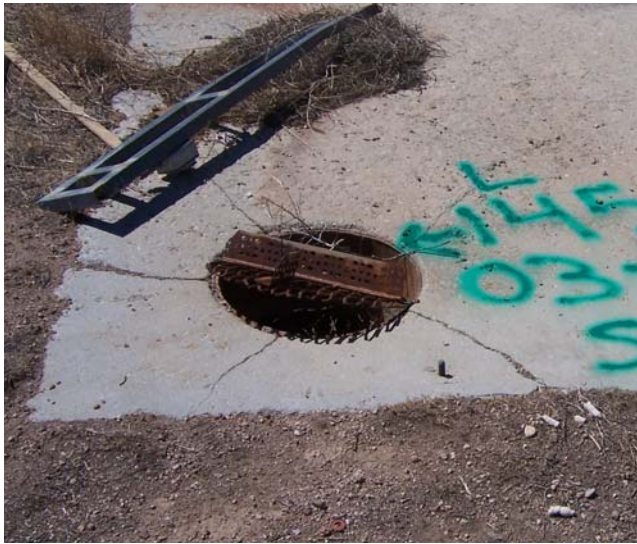
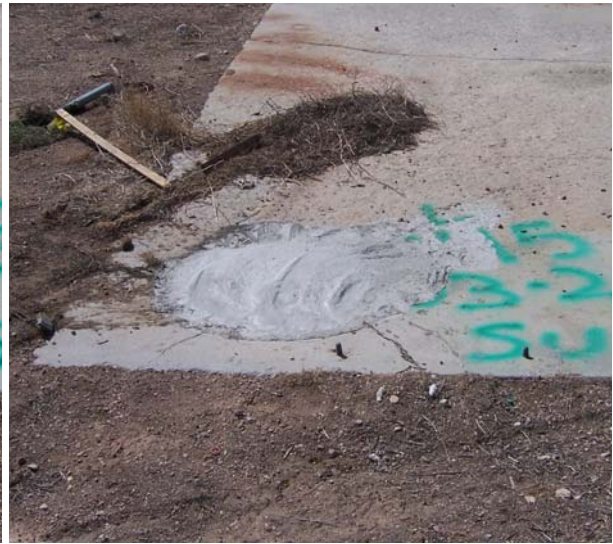
FIGURE 8. CAS 03-20-04, STEAM PLANT SUMP

Before (08/09/2007)

After (09/06/2007)

- CAS 03-20-04 (Injection Wells): Approximately 15 gallons of liquid were expected to be present in the steam plant sump; however, there was no liquid in the sump during closure activities. Removal of liquid was therefore not needed.

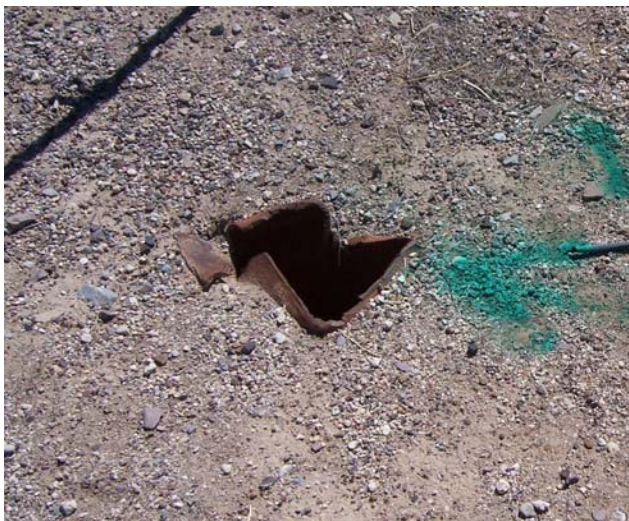
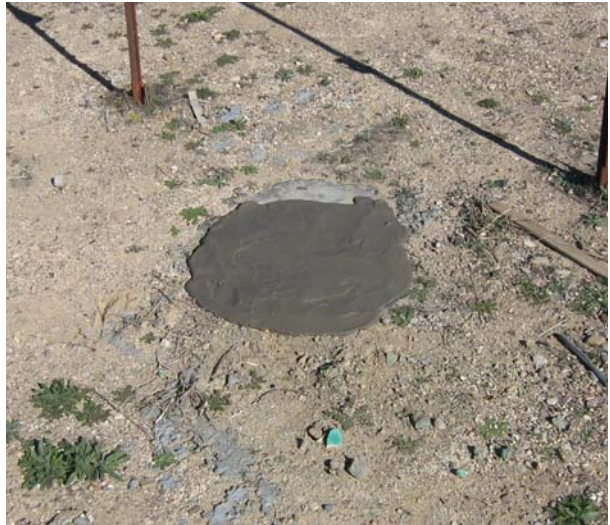
FIGURE 9. CAS 03-20-04, SITE E STEEL-CASED HOLE

Before (08/09/2007)

After (11/01/2007)

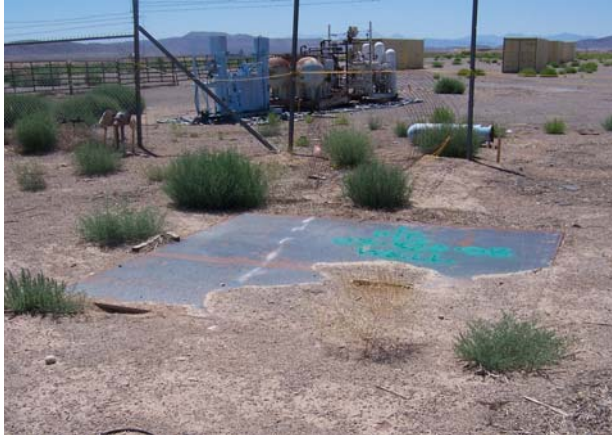
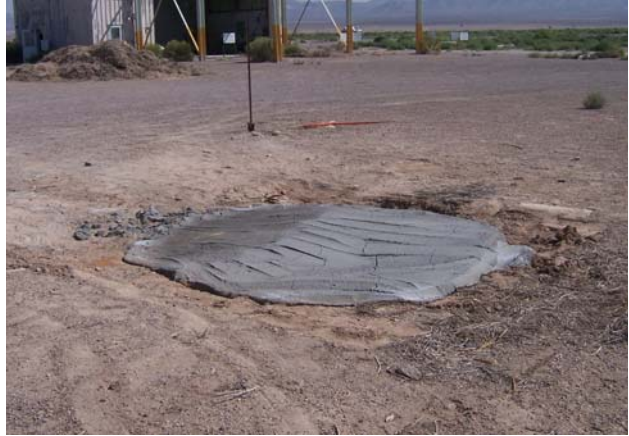
FIGURE 10. CAS 03-20-08, INJECTION WELL

Before (08/09/2007)

After (09/06/2007)

- CAS 03-20-08 (Injection Well): Approximately 8,310 gallons of liquid were expected to be present in the injection well and the sump; however, there was no liquid in either location during closure activities. Removal of liquid was therefore not needed.

CAS 03-20-08 is located in the J-6 yard in Area 3 of the NTS, just southwest of the Los Alamos Scientific Laboratory Post-Shot Building. No further action was required for closure of this CAS. As a BMP, the injection well and sump were filled with grout to grade. Metal covers from the well and sump were surveyed to verify that radiological contamination was less than the free-release limit established in the *NV/YMP Radiological Control Manual* (NNSA/NSO, 2004), after which the covers were placed back into metal stockpiles for use elsewhere on the NTS. No liquid was removed from either the well or the sump because both were dry during closure activities. Photographs of each location, before and after closure activities, are provided in Figures 10 and 11.

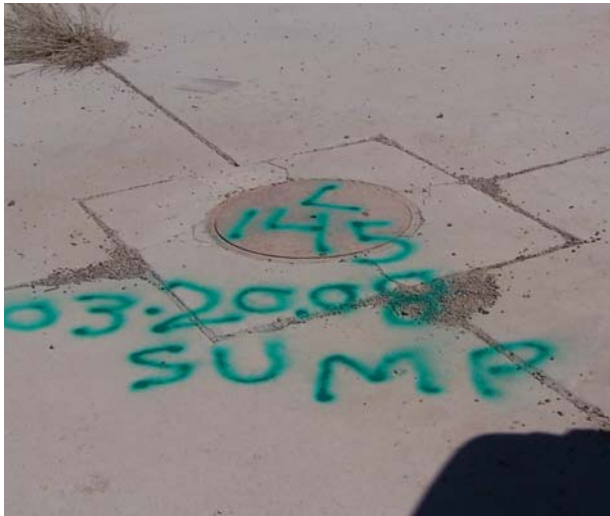
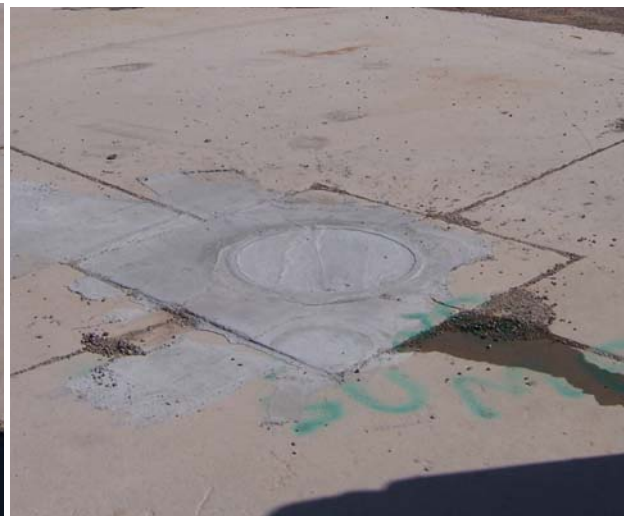
FIGURE 11. CAS 03-20-08, SUMP

Before (08/09/2007)

After (09/06/2007)

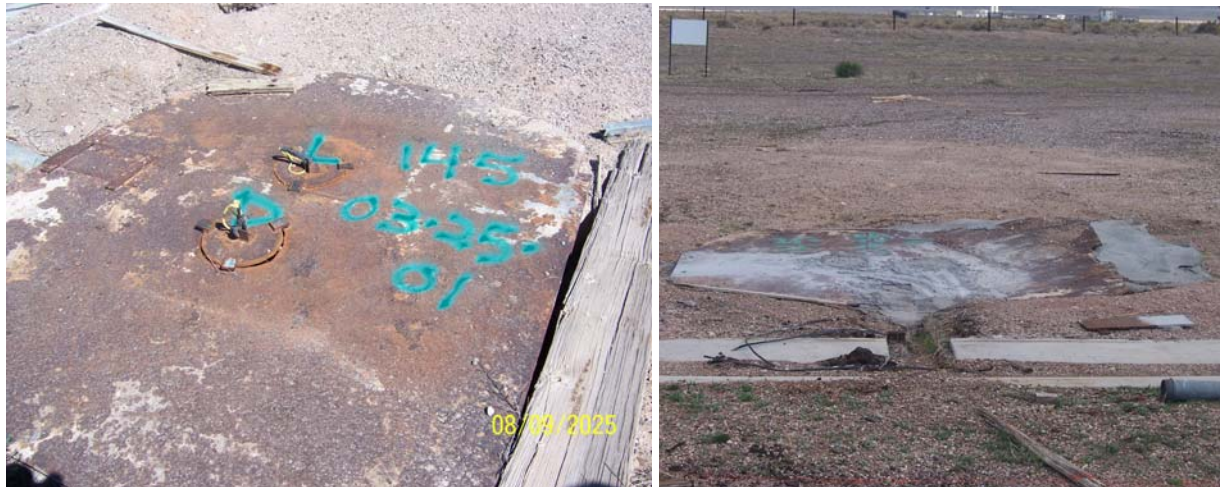
FIGURE 12. CAS 03-25-01, VERTICAL PIPES AND SUMP

CAS 03-25-01 is located at the former Area 3 Subdock Complex. Surface soil is contaminated with lead, and subsurface soil is contaminated with pentachlorophenol and arsenic at levels requiring restricted use of the area for personnel protection. The site also has two vertical pipes surrounded by a sump. Approximately 100 gallons of liquid were expected within the north pipe based on observations during the corrective action investigation; however, very little liquid was present during closure activities. The volume of liquid was insufficient to pump without also pumping sludge. This site was closed in place with administrative controls.

- CAS 03-25-01 (Oil Spills): Approximately 100 gallons of liquid were expected to be present in the north pipe; however, there was little liquid present at the time of closure activities. The minimal liquid was stabilized in place using a drier grout mixture, after which the remainder of the pipe was filled with grout.

Before (08/09/2007)

After (10/16/2007)

Both of the vertical pipes were filled with grout to grade. A drier mix was used initially in the north pipe to solidify any liquid and sludge at the liquid-sludge interface. Additional grout was poured to fill the sump around the pipes. The cover was not removed from the sump because it

was welded to the pipes. The pipe covers were removed, surveyed to verify that radiological contamination was less than the free-release limit established in the *NV/YMP Radiological Control Manual* (NNSA/NSO, 2004), and placed into metal stockpiles for use elsewhere on the NTS. Photographs of the pipes and sump, before and after closure activities, are provided in Figure 12.

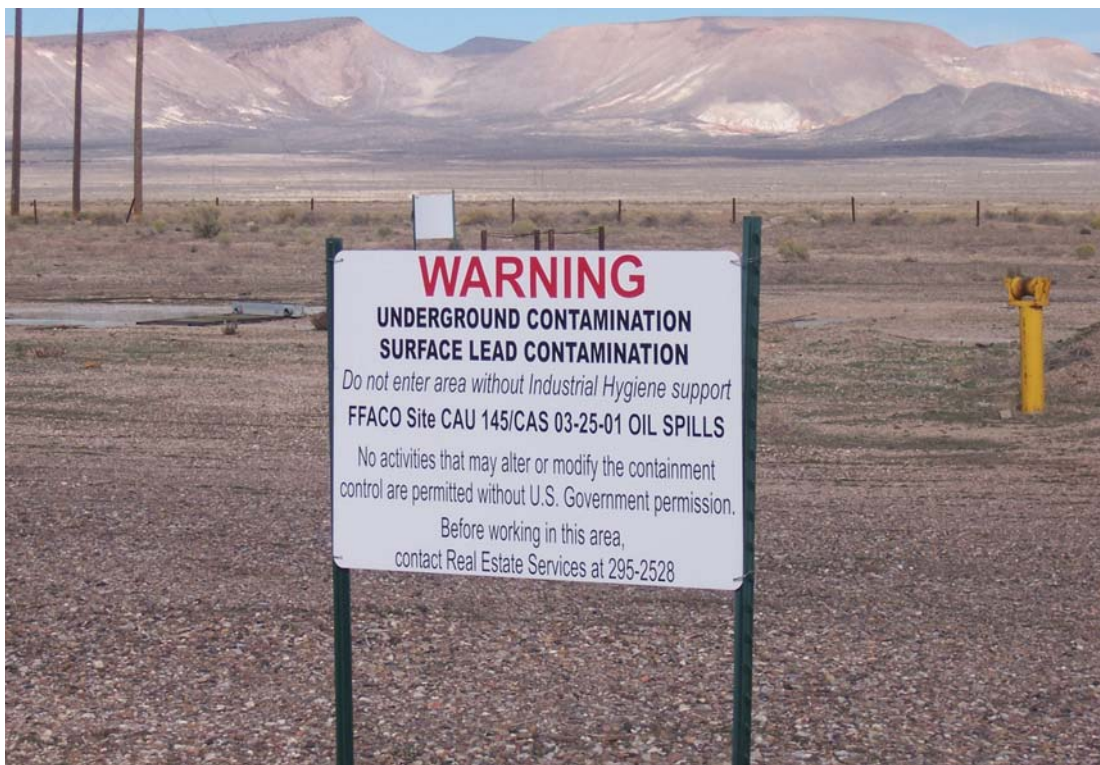
FIGURE 13. CAS 03-25-01, USE RESTRICTION SIGN

(10/15/2007)

This CAS has been use restricted for lead contamination of surface soil and for pentachlorophenol and arsenic contamination of subsurface soil. UR signs are posted on all four sides of the use-restricted area to warn against intrusive activity according to the FFACO UR posting guidance (FFACO, 2003). The signs also include a cautionary statement about the surface hazard.

Surface and subsurface soil contamination was closed in place with a UR. Signs were posted on each side of the use-restricted area as a warning about the hazards (Figure 13). A copy of the implemented UR is provided in Appendix A. Post-closure requirements are described in Section 5.2.

Inspections will be performed annually to verify that signs are in place and legible and the UR is maintained. Maintenance or repair needs that are identified will be scheduled within 90 working days of discovery and documented in writing at the time the work is done. Inspection results will
